The Rose and Crown, Chellaston.

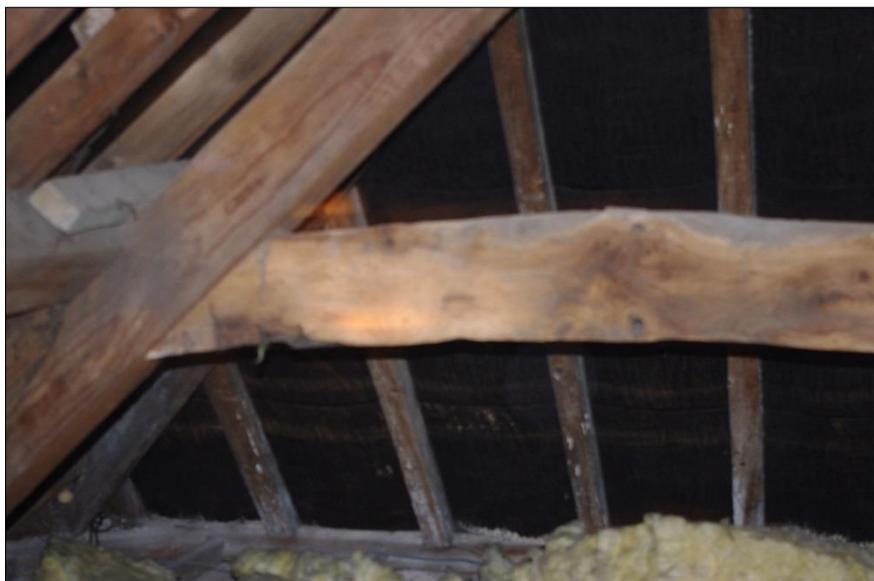
Investigation of the attic is difficult, but there is a tie-beam which does not seem to have been machine-cut (see photograph below). It is massive and could well be a re-used timber of E.M. date. Careful investigation of the building could possibly reveal more.

The cross-beam appears to be un-machined. Note contrast with the machined ones.

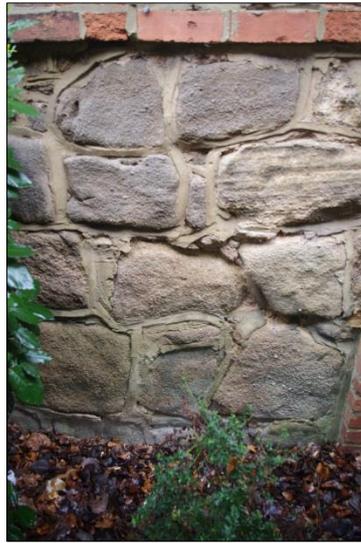
Finally, to the left of the entrance from the carpark is a late building attached to the Rose and Crown. This was probably a former outbuilding. It contains a considerable length - approx. 12ft - of stone walling, which is not "rubble". It could indicate a much earlier outbuilding, probably for animals?

Stonework remaining today
